HP LaserJet 4200 Series– Duplex Printer Error

Recently, TSD's Technical Support has identified a reoccurring print problem with the 4200 series printers with duplex option installed.

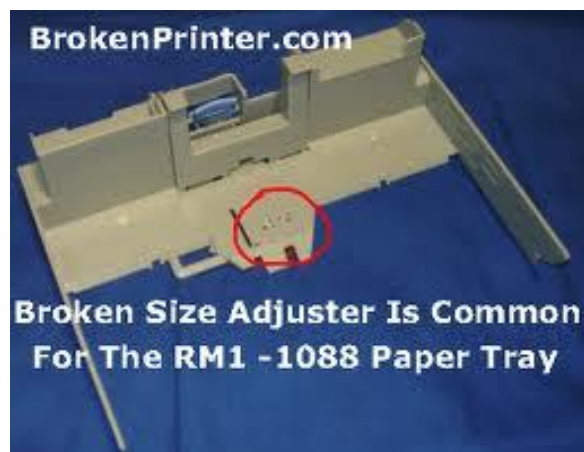
The duplex print error is linked to a broken stop plate in the rear of the paper tray. This stop plate is responsible for activating the paper size fingers which determines paper size within tray. Unfortunately, the printer does not display a paper jam or printer error when this occurs.

Below we have included a picture of a tray with a defective stop plate for better identification.

To best diagnose this problem, TSD Technical Support suggests inspection of stop plate on paper tray. Replacement of tray (RM1-1088; HP 4200/4250/4300/4350 500 Sheet Paper Tray) is necessary where stop plate is broken.
